**MALFUNCTION OF IGNITERS IN
THE AMRA VARIABLE PARAMETER
ROCKET ENGINE**

TECHNICAL NOTE

JULY 1965

**MATERIALS ENGINEERING DIVISION
U. S. ARMY MATERIALS RESEARCH AGENCY
WATERTOWN, MASSACHUSETTS 02172**

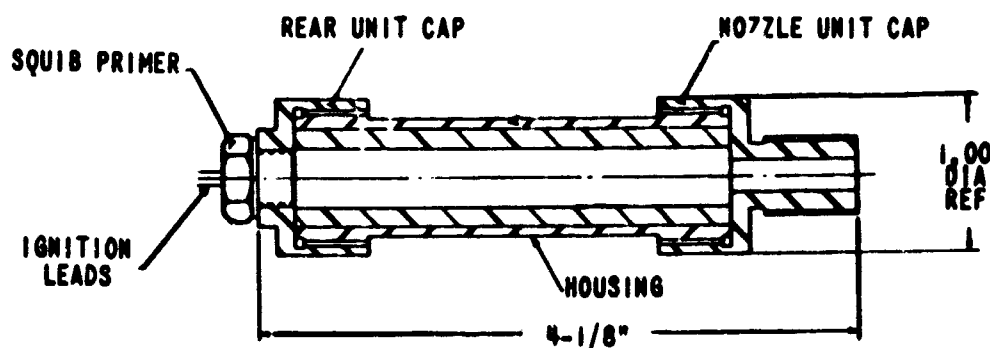
Figure 3. IGNITER ASSEMBLY

The igniter consists of an igniter-charge bonded to the wall of a cylindrical steel case. The nozzle end is threaded and screwed through a closure plate attached to the side wall of the combustion chamber. In the opposite end is a squib containing a primer charge, insulated pressure-sealed electrical connections and lead wires.
